Subject: Department of Natural Resources Washington Geological Survey,  
School Seismic Safety Assessments Project Phase 2, Contract No. AE 430 -  
Seismic Evaluation for **Spokane**

## **School Buildings Evaluated in the Spokane School District**

1. Bancroft (The Community School), Main Building
2. Bryant Center, Main Building
3. Havermale (Montessori), Main Building 1928 and 1940 Areas
4. Havermale (Montessori), Main Building 1928 Gym
5. Havermale (Montessori), Main Building 1965 Areas
6. Madison Elementary School, Main Building

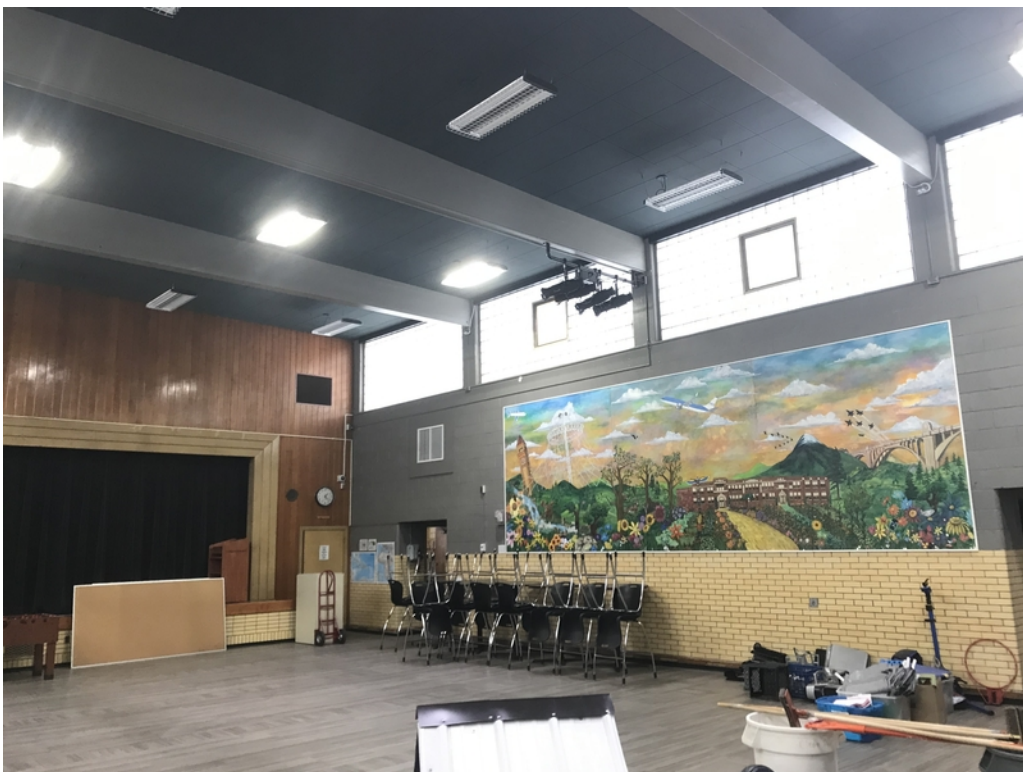
**Figure 1-3. Multipurpose room with stage.**

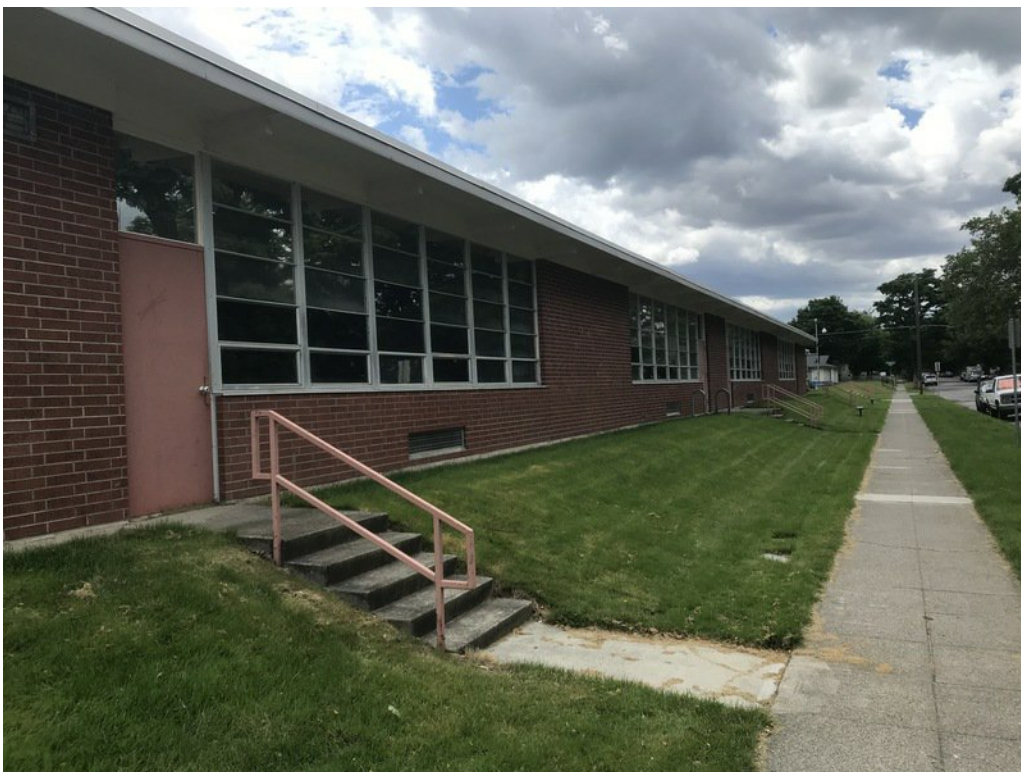
**Figure 1-6. North side of the building**

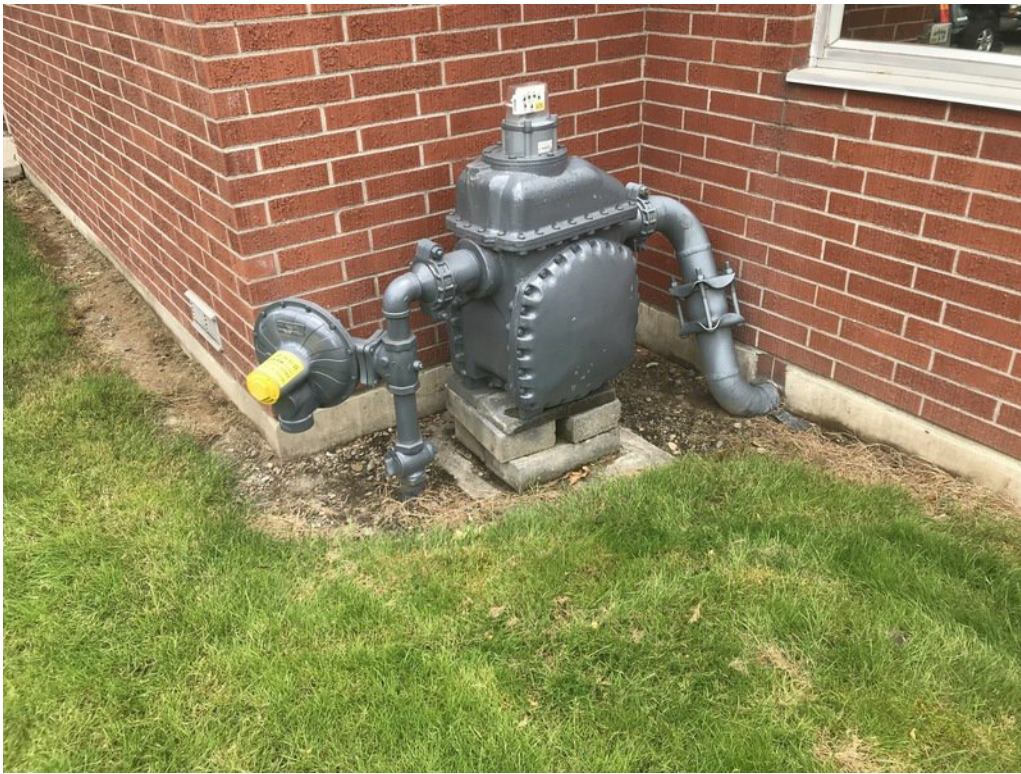
**Figure 1-7. Water access point on the north side of the building.**

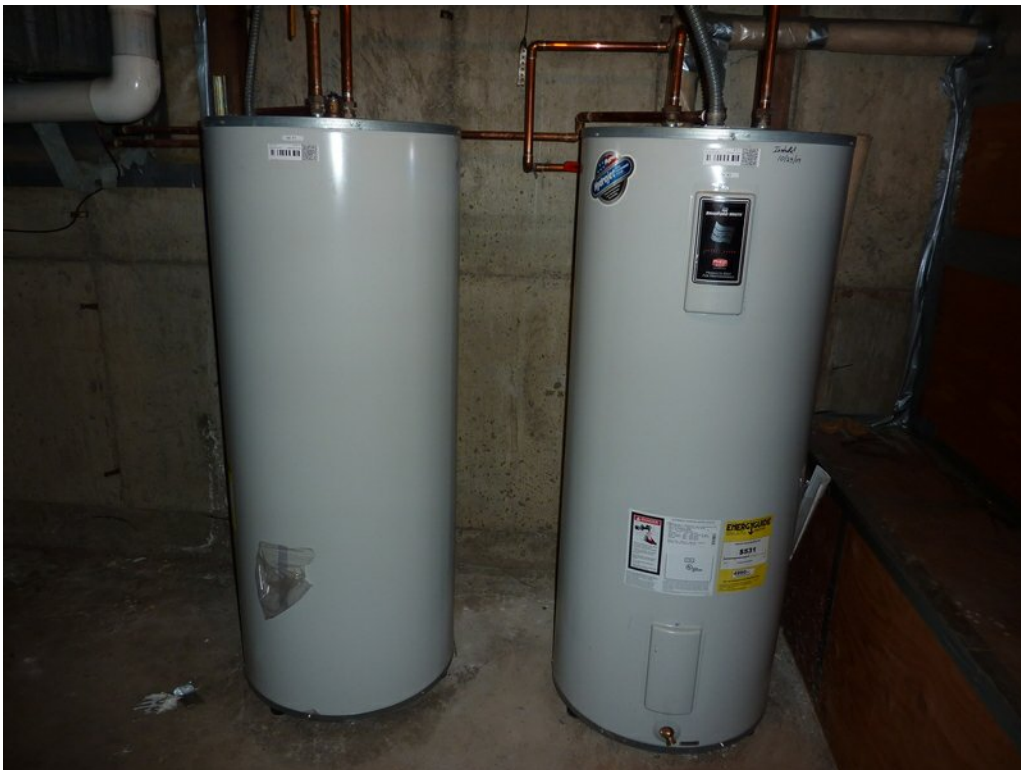
Figure 1-2. Water heaters in crawlspace at south end of gymnasium.

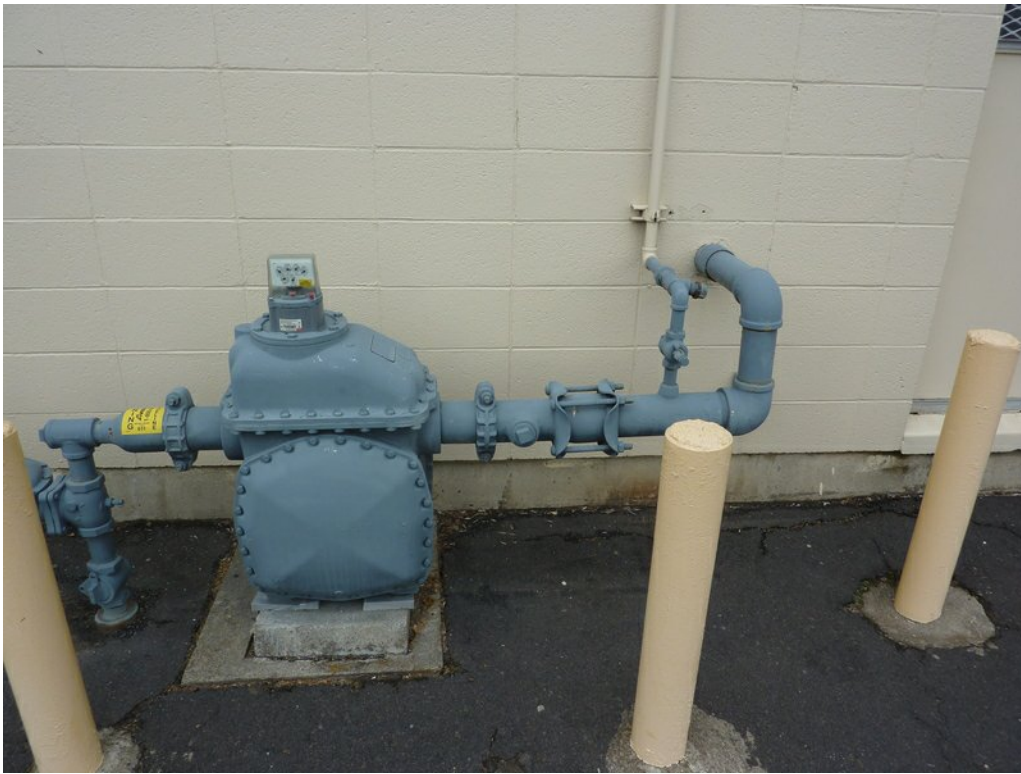
**Figure 1-3. Exterior gas meter with emergency shut-off. Shut-offs visible at each individual mechanical unit.**

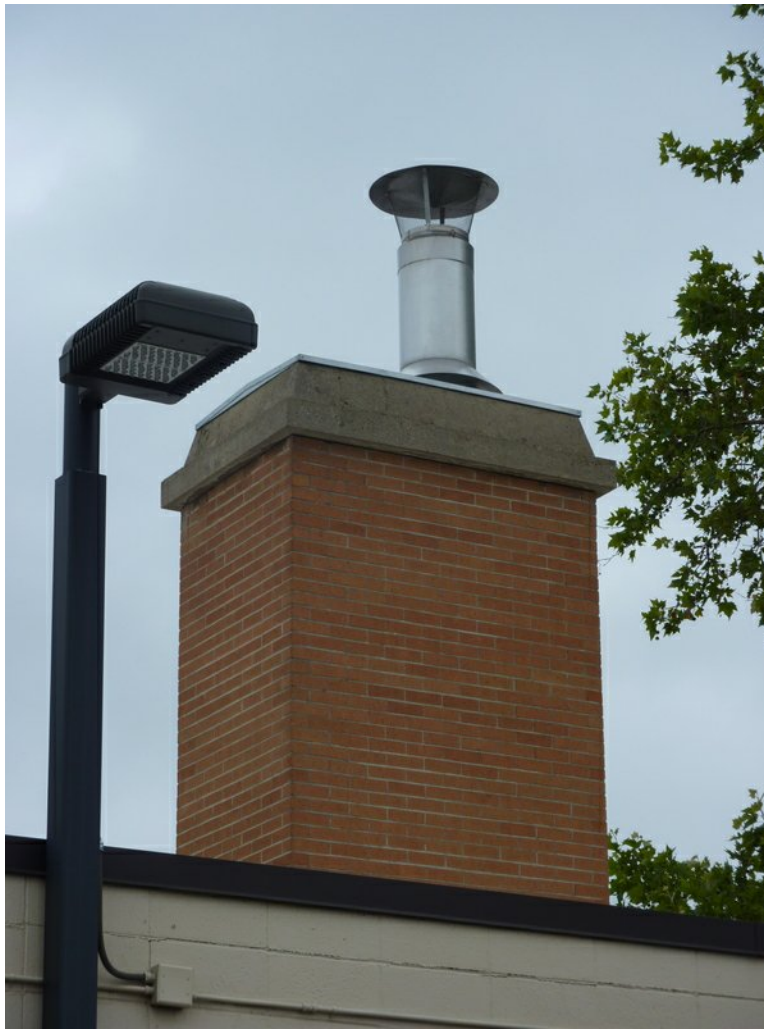
Figure 1-4. Large chimney at mechanical room, presumed to be URM.

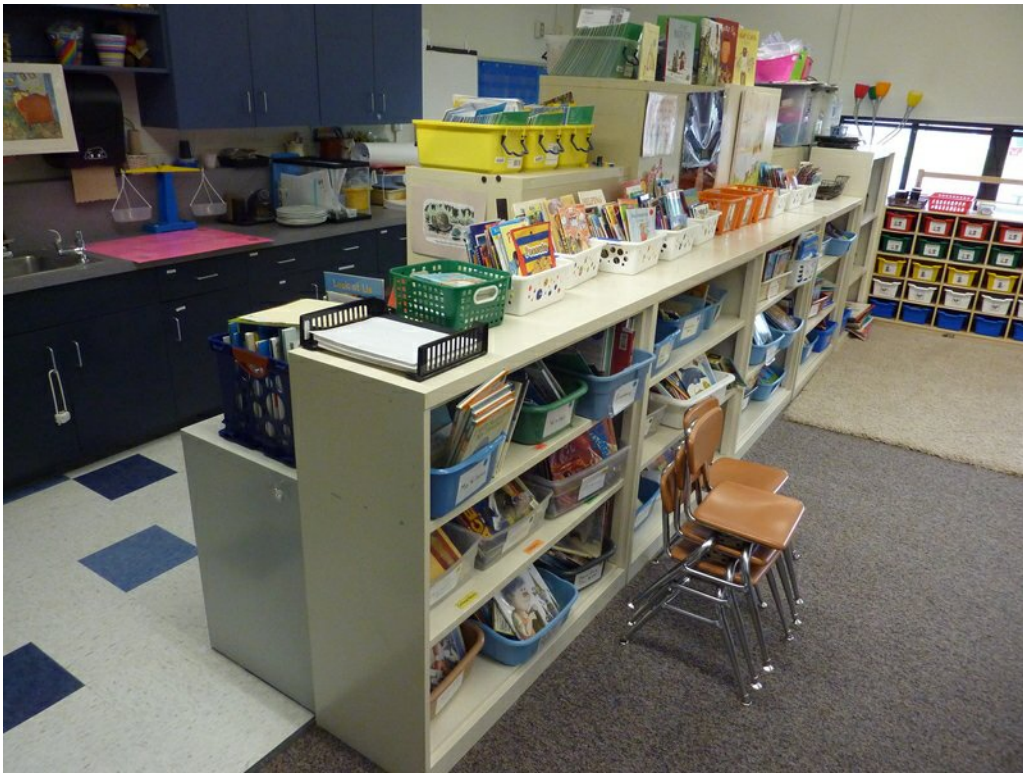
Figure 1-5. Back-to-back unrestrained shelving.

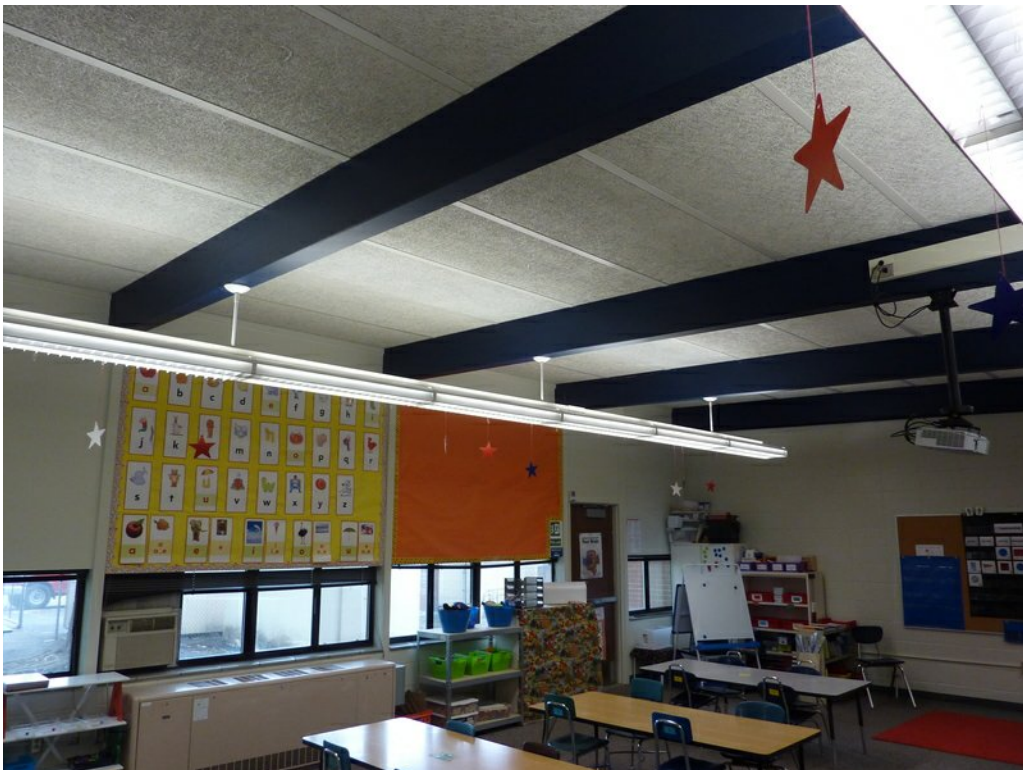
Figure 1-6. Typical classroom.

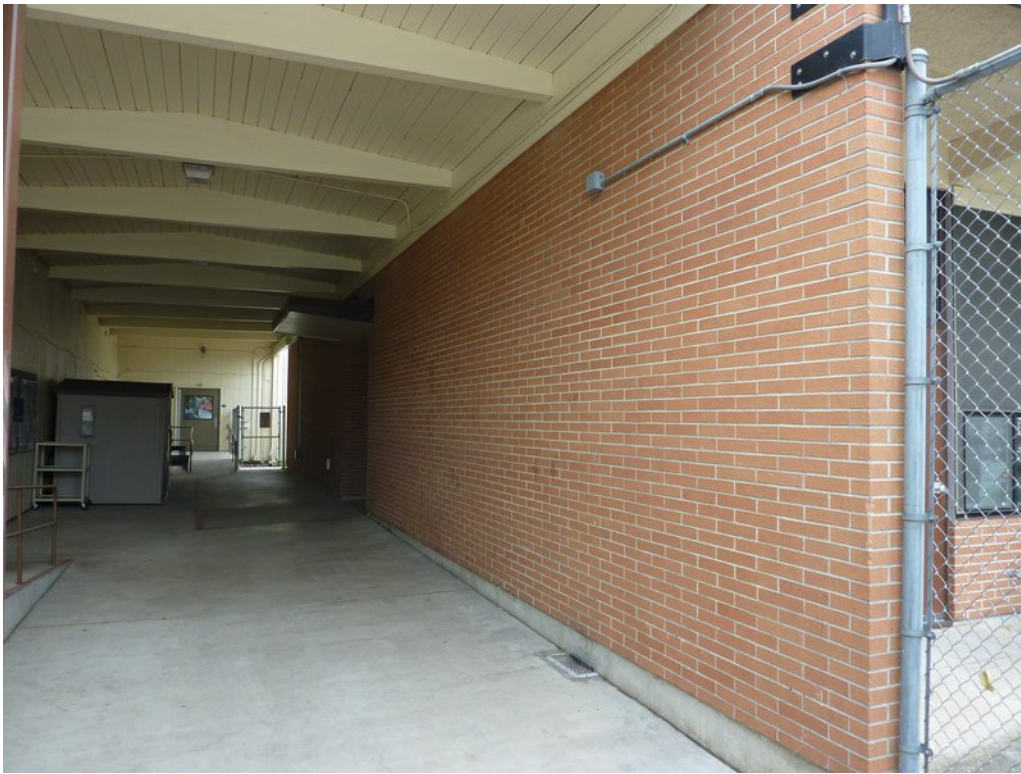
Figure 1-7. Breezeway at north face of north wing of building.

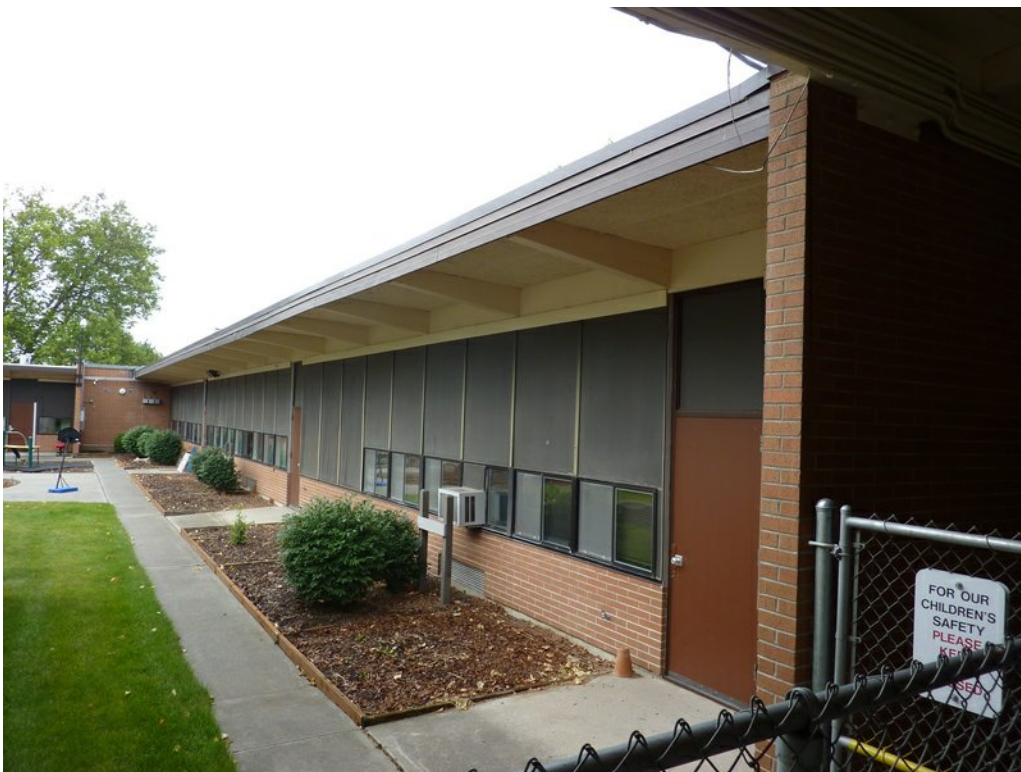
Figure 1-8. East side of north wing.

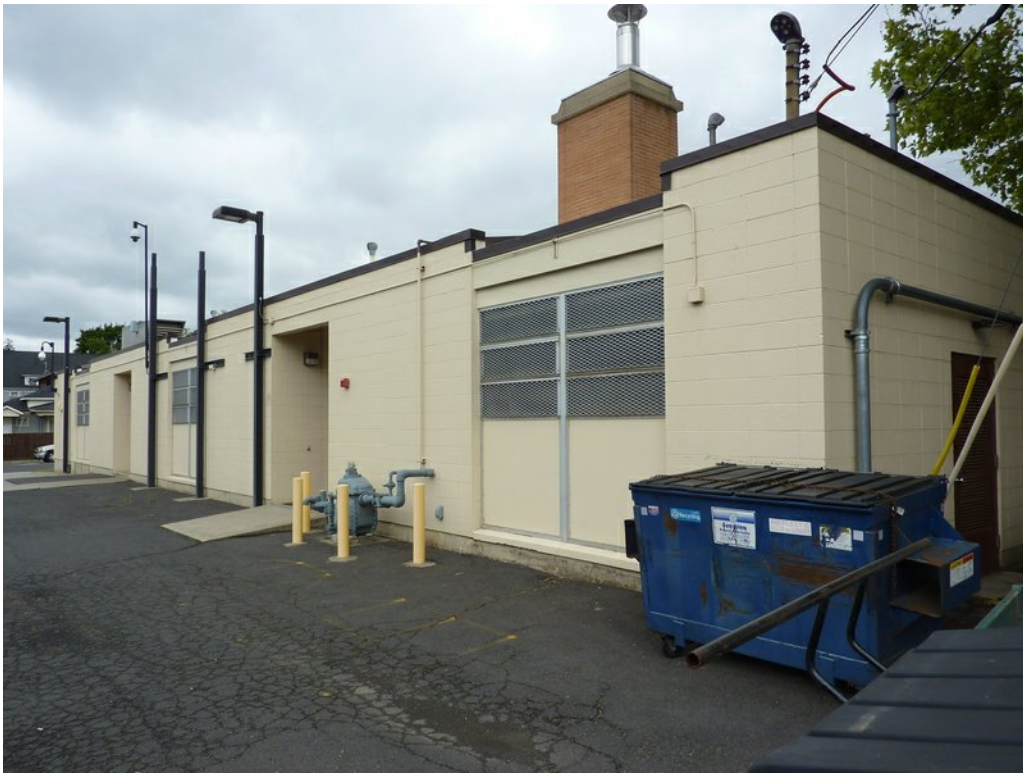
Figure 1-9. South face of south end of building.

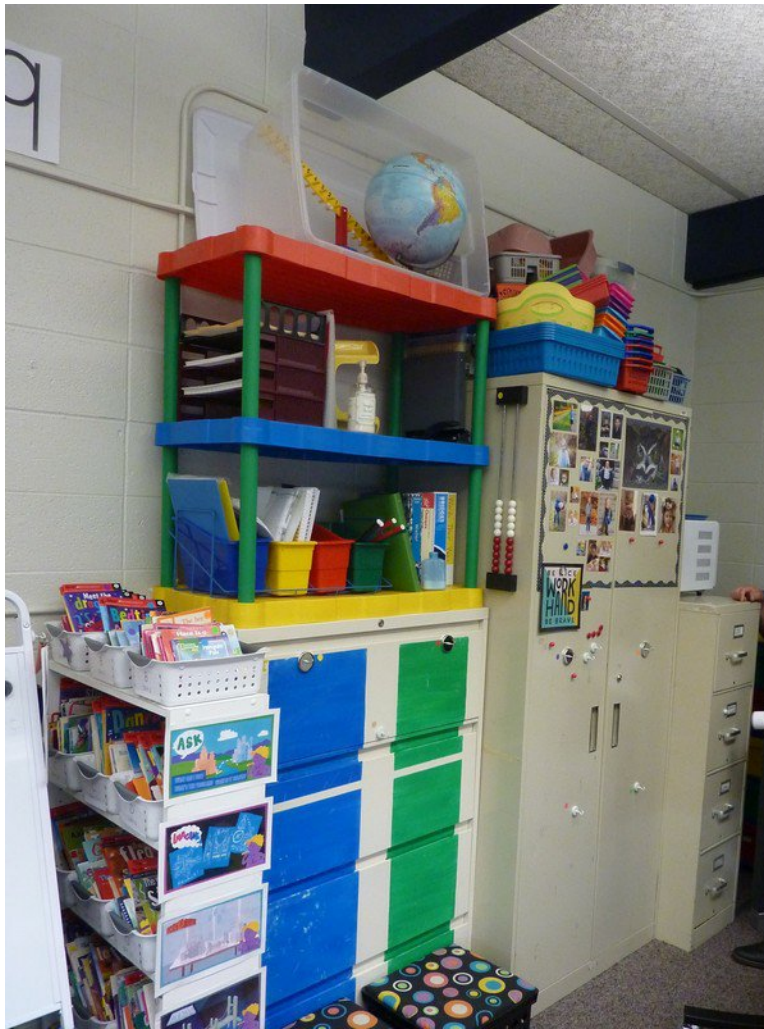
Figure 1-10. Unrestrained storage units.

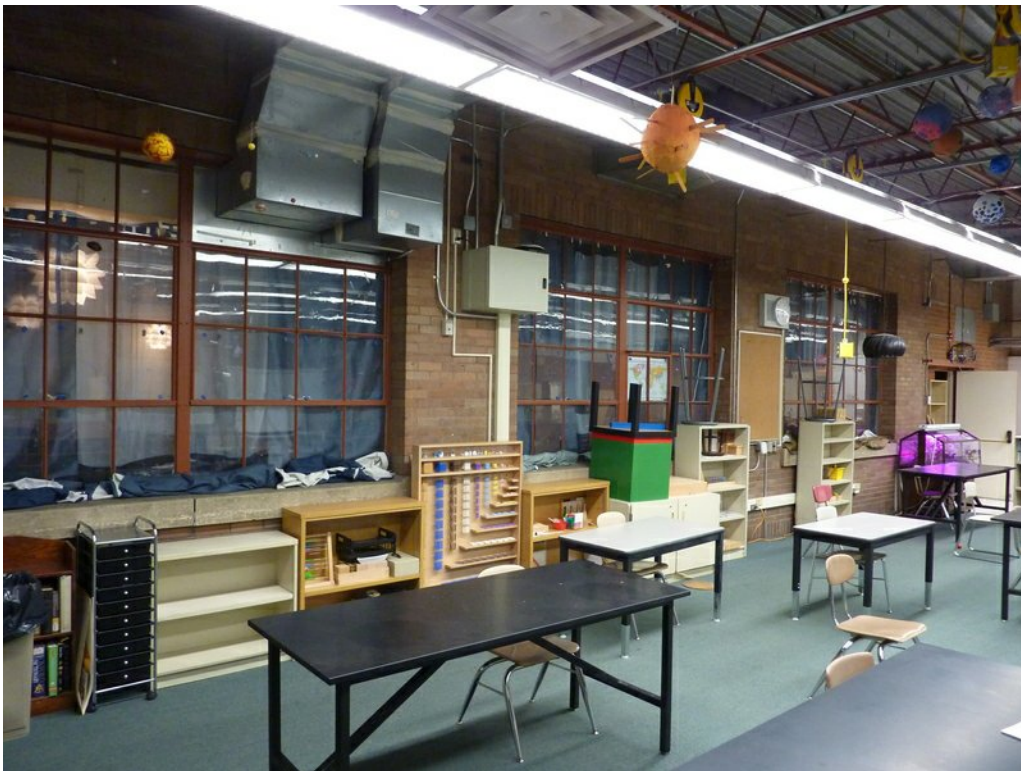
**Figure 1-2. Classroom in 1980 addition.**

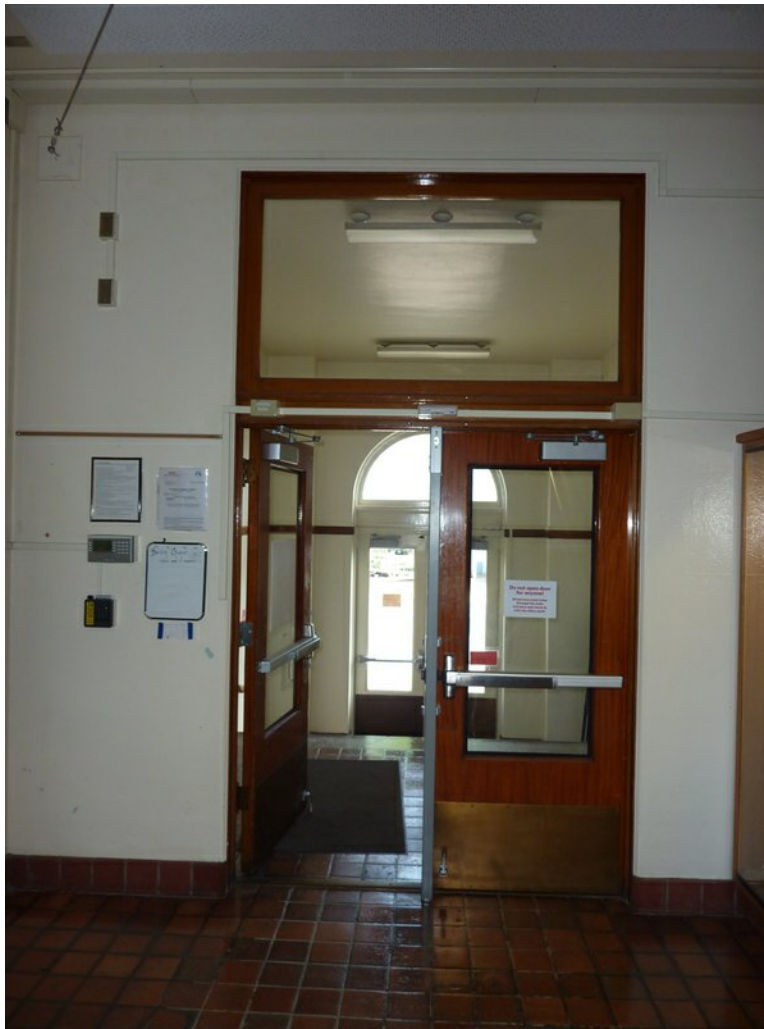
Figure 1-3. Northwest entry with large window over doorway.

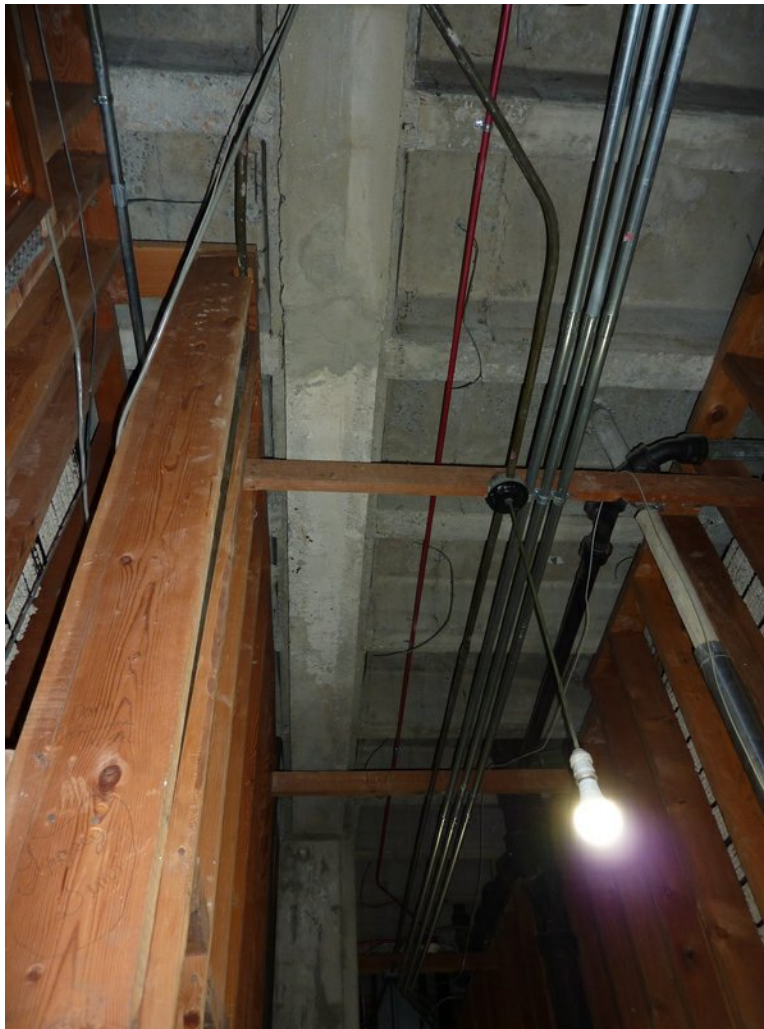
Figure 1-4. Looking up at second floor of original building. Concrete column in the bottom of the shot.

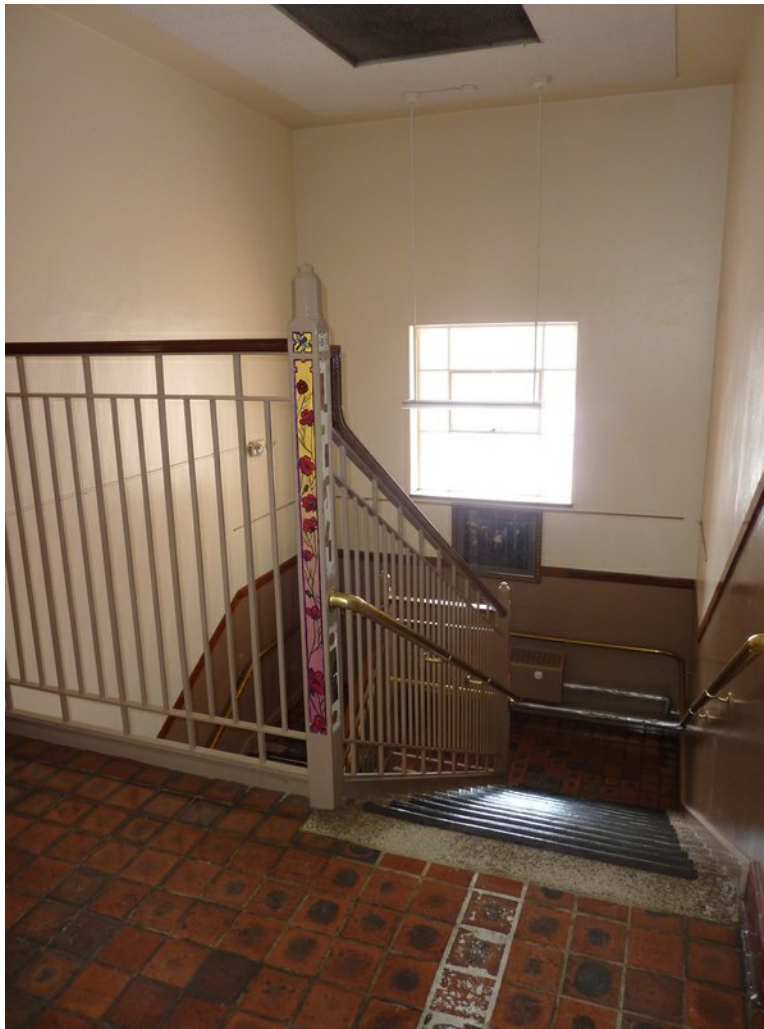
Figure 1-5. Typical stairway, four stairwells in building. One elevator by southwest stairwell (1960 addition).

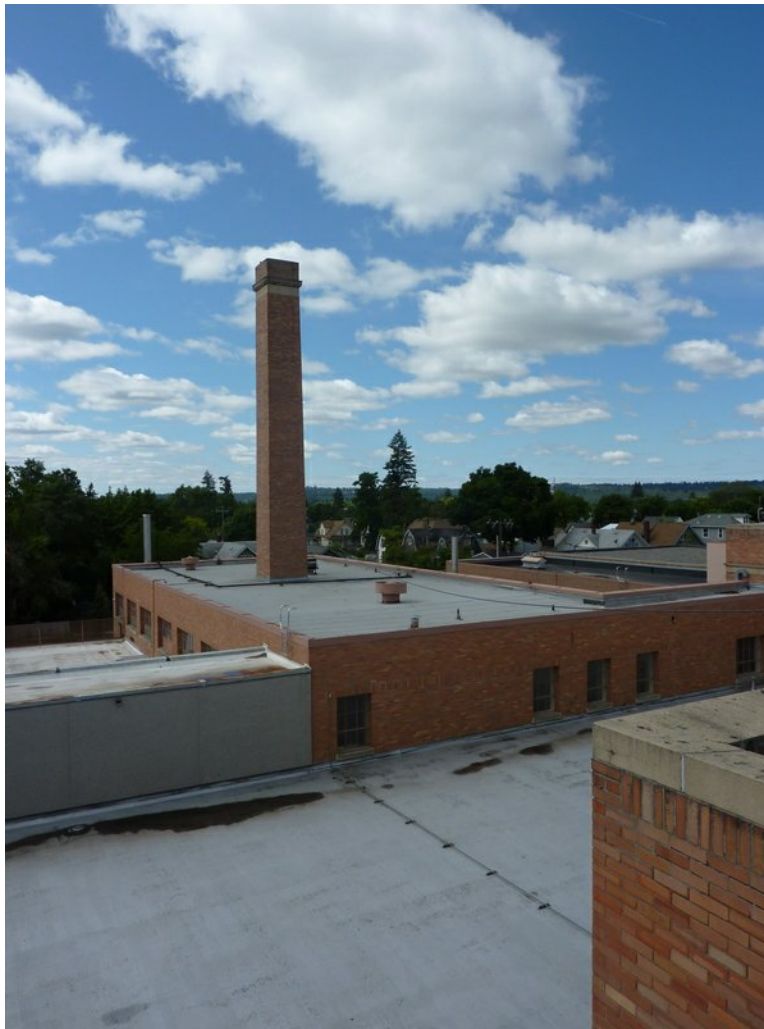
**Figure 1-6. Rooftop view looking south; centered on 1941 addition, 1965 addition to the left (grey), 1965 addition on the right with access ladder, original gymnasium roof on far right. Roof of 1965 addition bottom half of picture.**

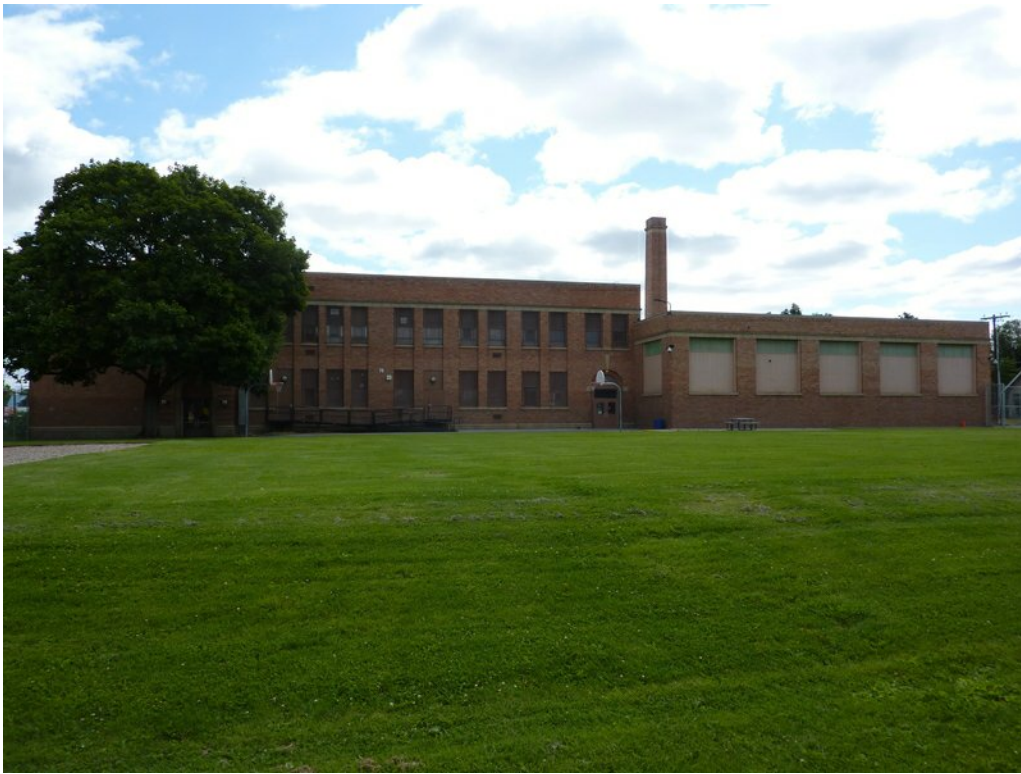
**Figure 1-7. West face of building.**

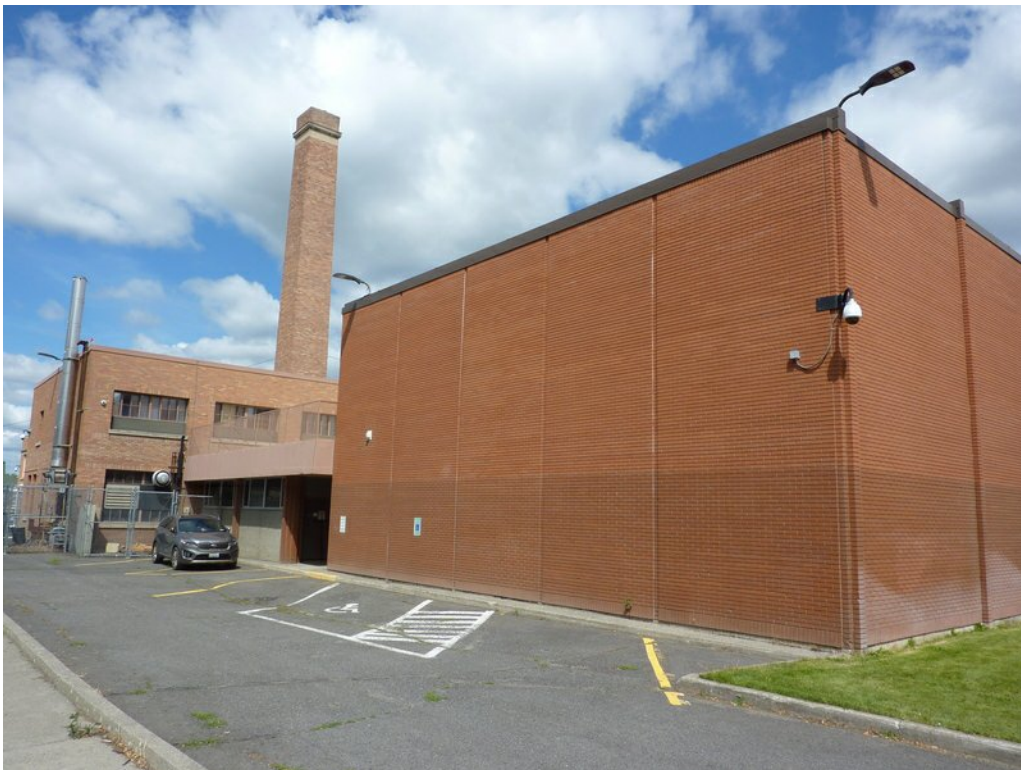
**Figure 1-8. South face of 1965 addition (gymnasium). Original mechanical wing + 1941 addition on left.**

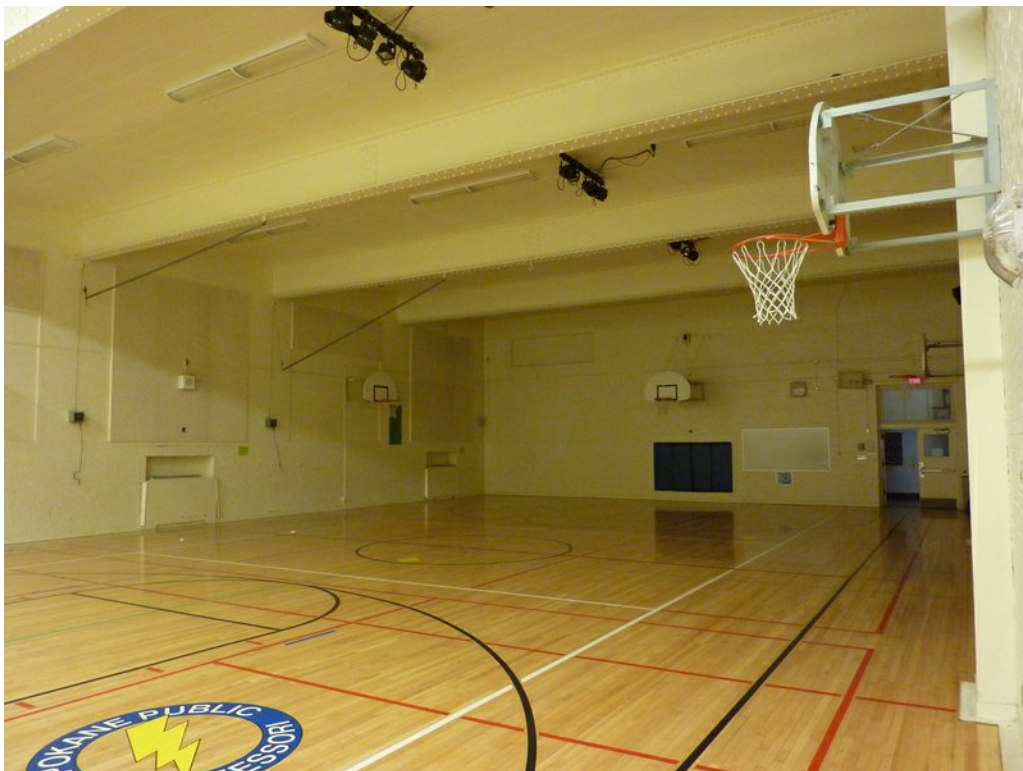
Figure 1-2. Interior of gym space w/ built-up steel girders visible.

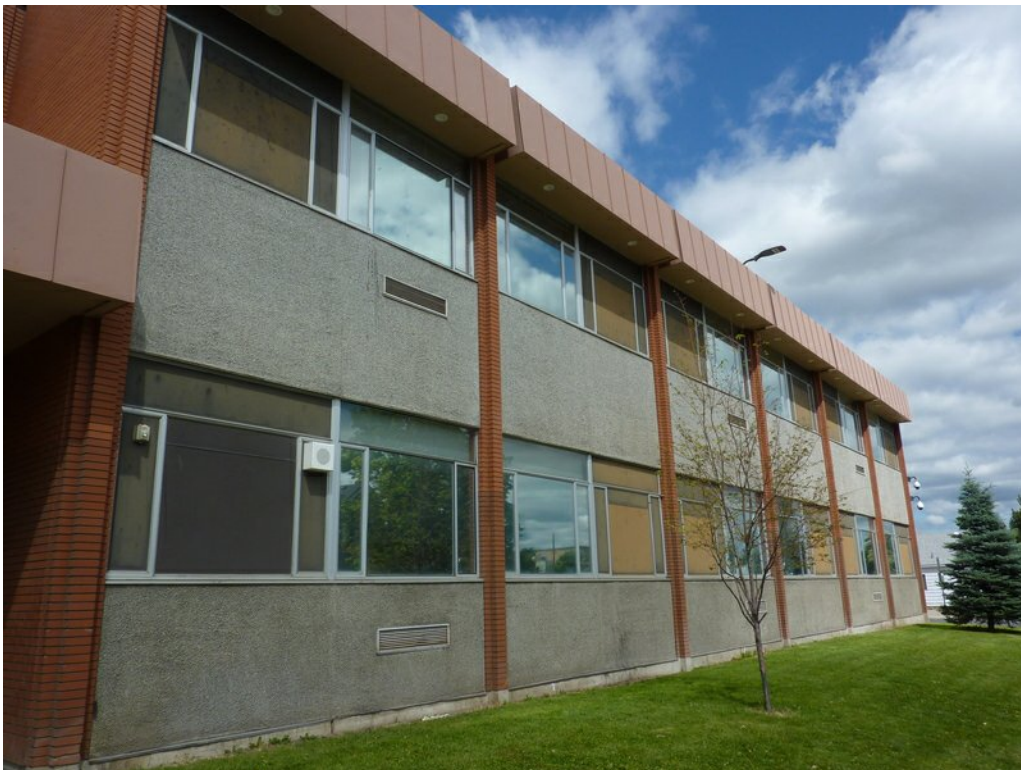
**Figure 1-2. East face of building.**

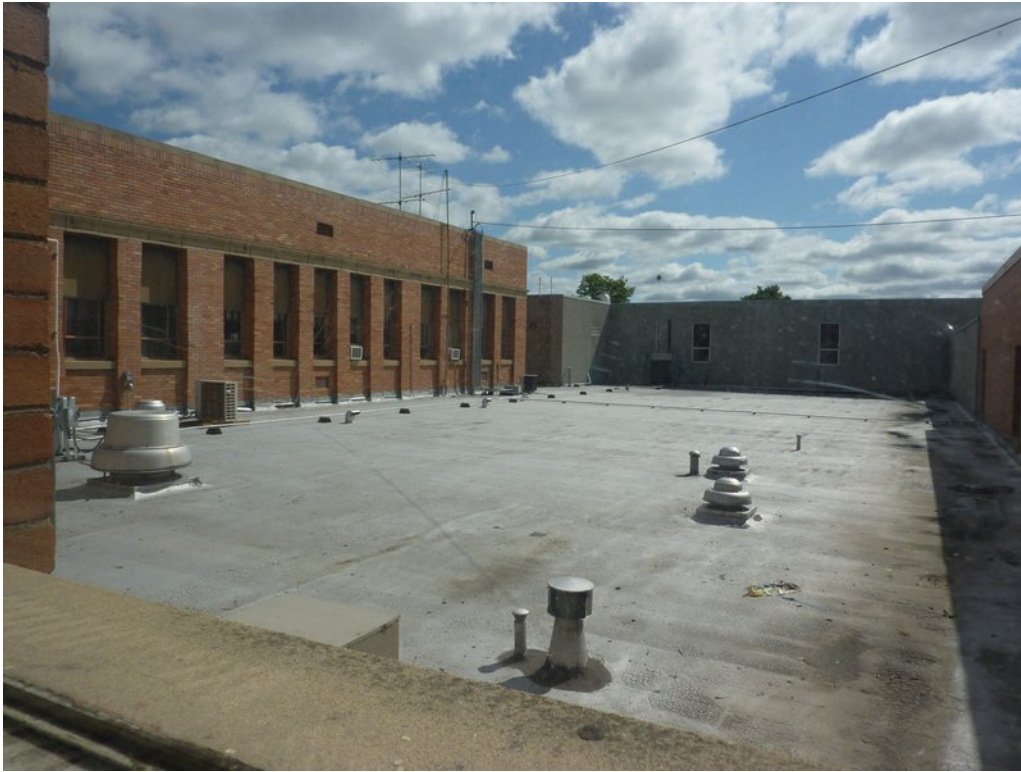
**Figure 1-3. Looking west from window in original 1928 building over roof of cafeteria space toward the 2-story portion of the 1965 building (grey exterior finish to the right of the photo).**

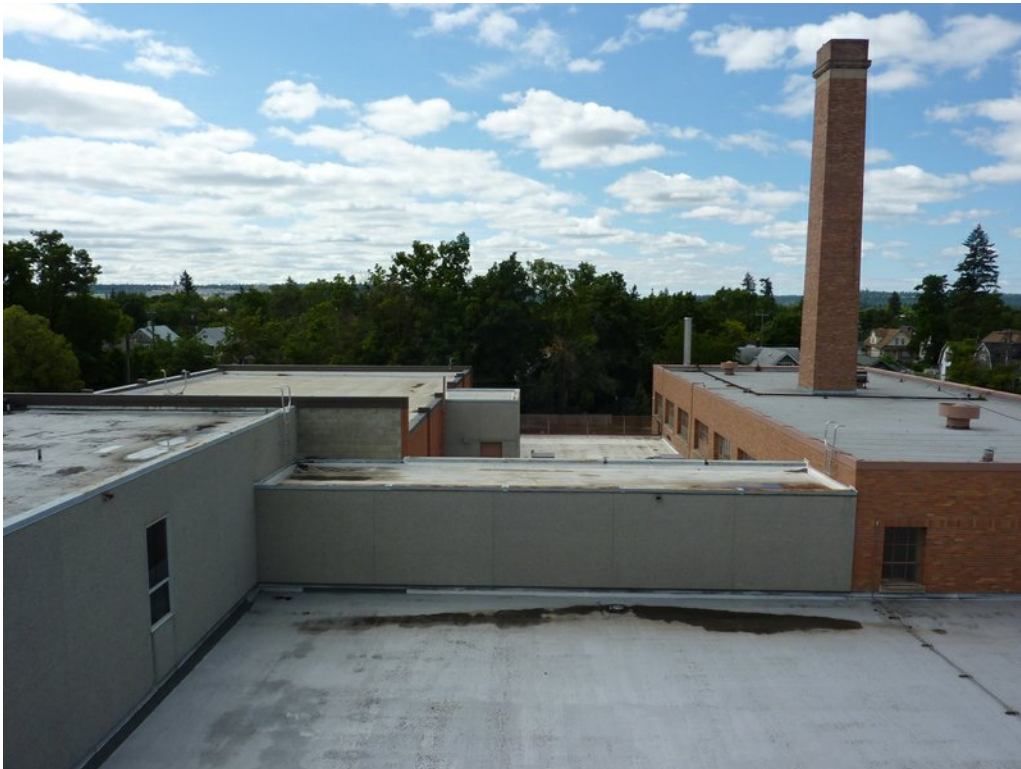
**Figure 1-4. Looking south over the roof of the cafeteria toward the roof of the gym space (to the left), roof over the single-story classroom area (center, background), and the two-story space over the boiler room in the original 1928 building with the URM chimney (to the right).**

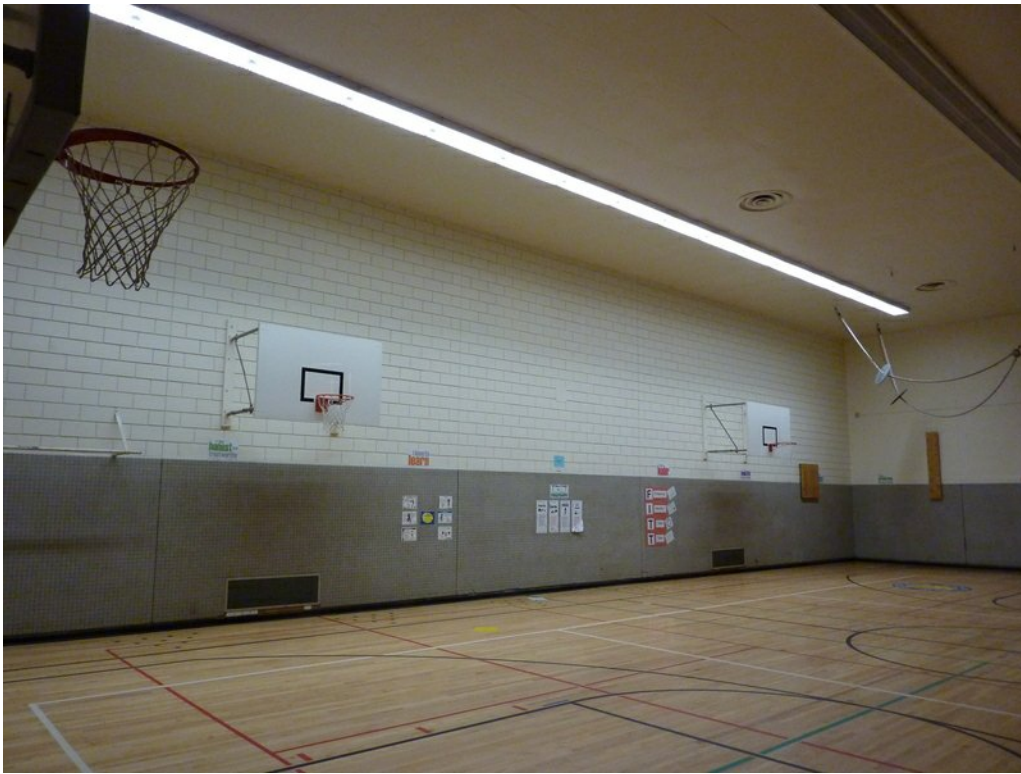
Figure 1-5. Interior photo of gym space in this building.

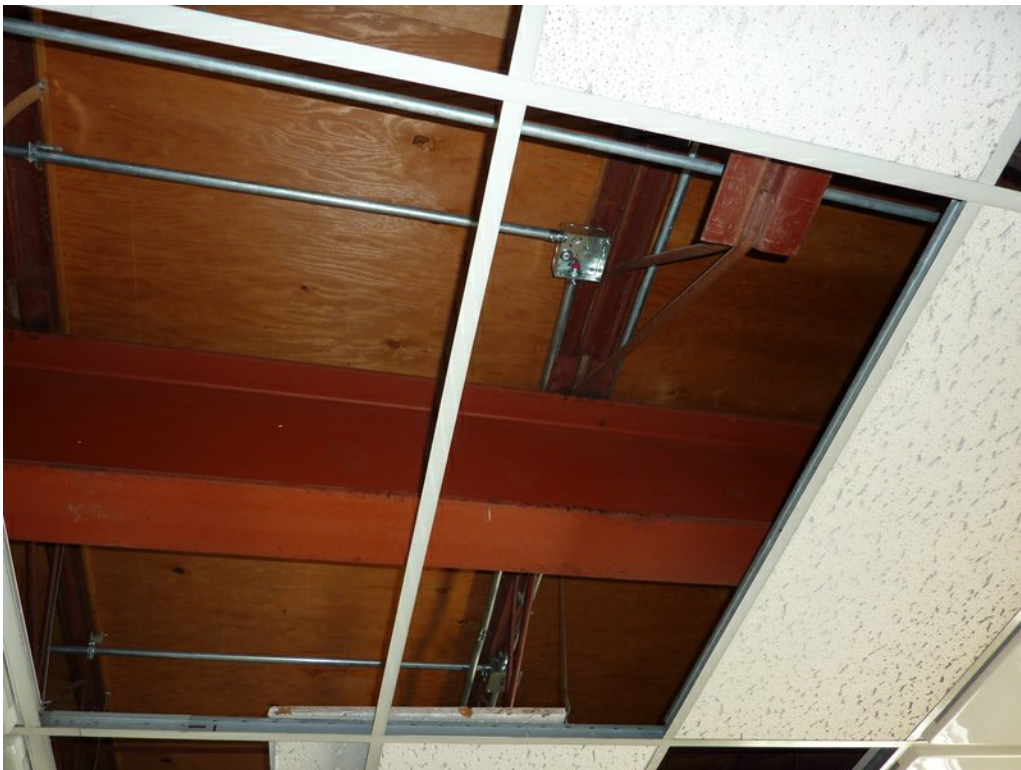
Figure 1-6. Typical roof structure.

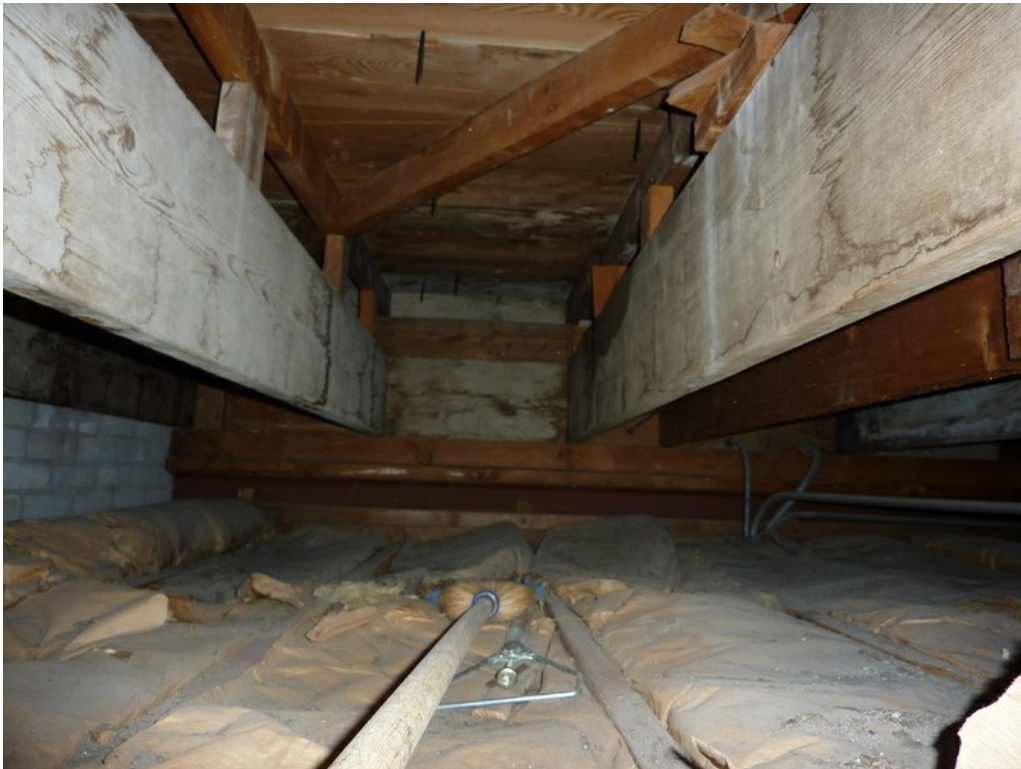
**Figure 1-2. Picture in ceiling space adjacent to gymnasium. Straight sheathing visible above 2x sleepers on blocking to achieve roof slope. 2x12 joists pictured. Ledger on far left of picture had visible bolting at approximately 2-ft OC to URM.**

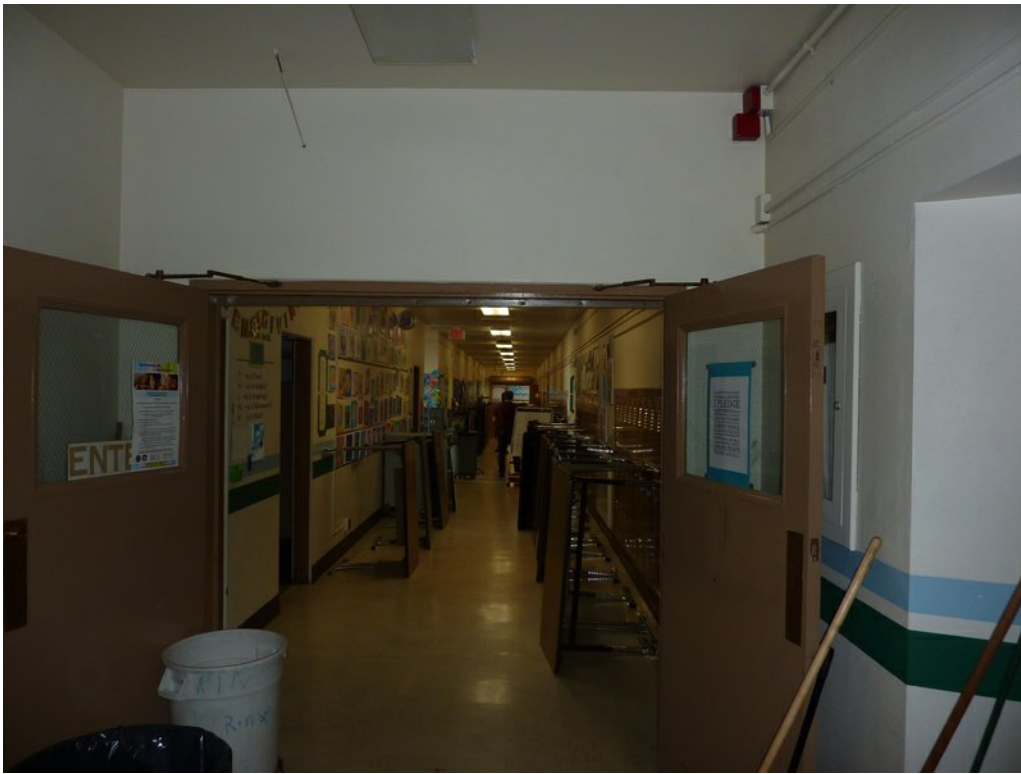
**Figure 1-3. Typical corridor.**

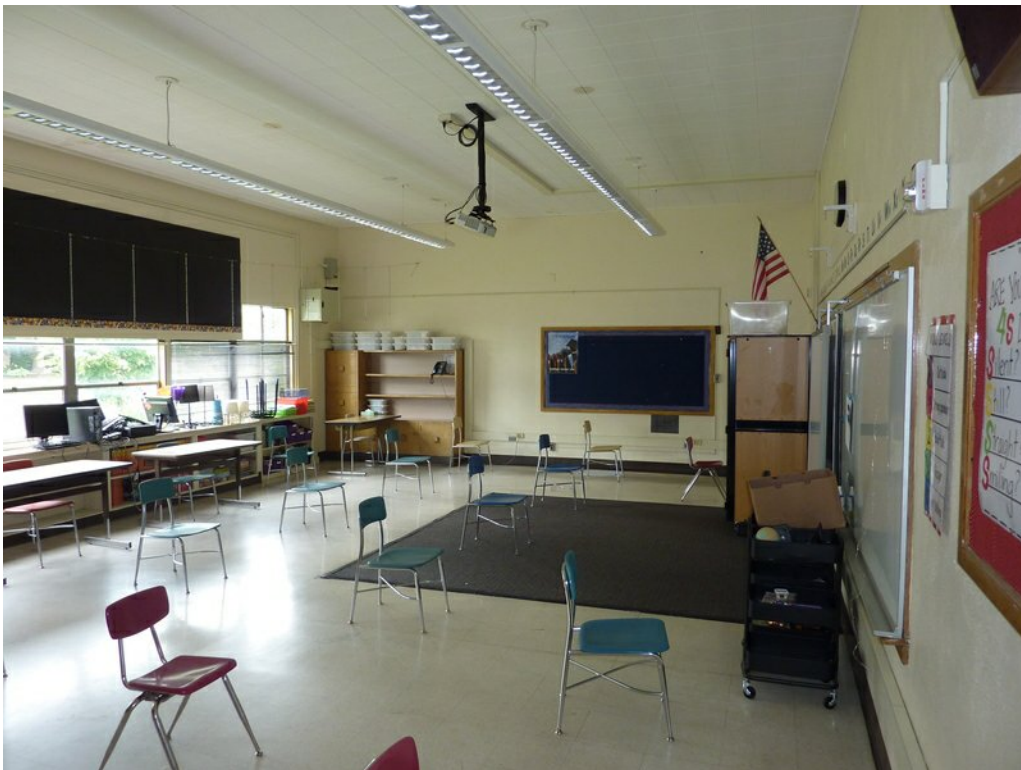
**Figure 1-4. Typical classroom. Built-in cabinets with counter and sink and overhead storage on opposite wall (not pictured). All cabinetry with latching doors.**
